RCL-ENVESS22M868LOR-01/A (01)

## CLIMATIC TEST REPORT

### Pressure variation test

Equipment under test:  
Linear indicator with digital display

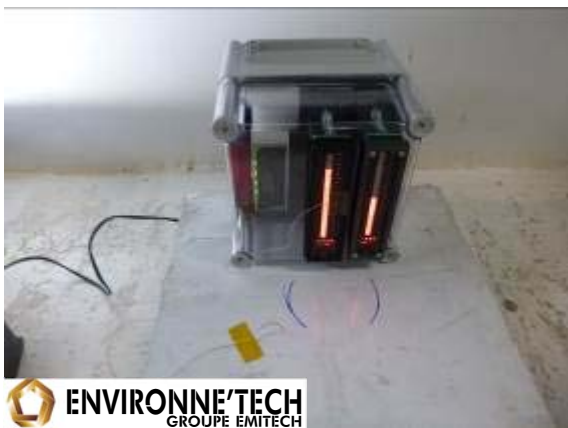
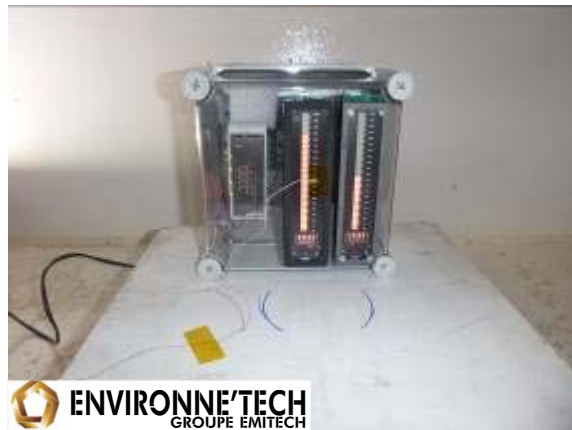
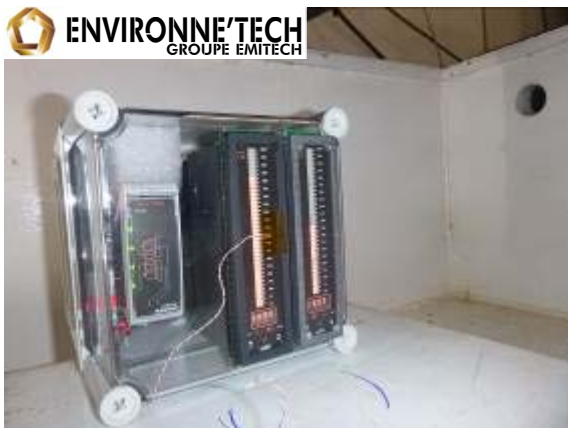
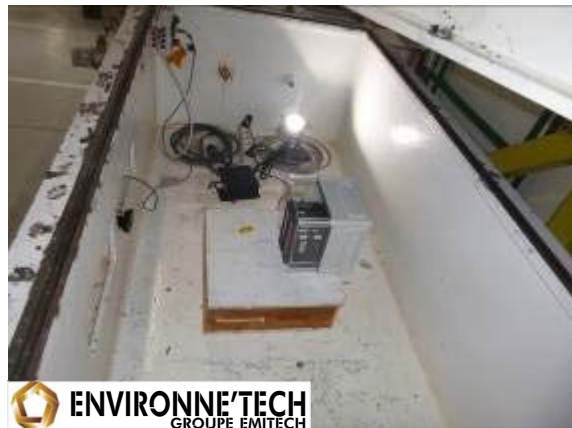
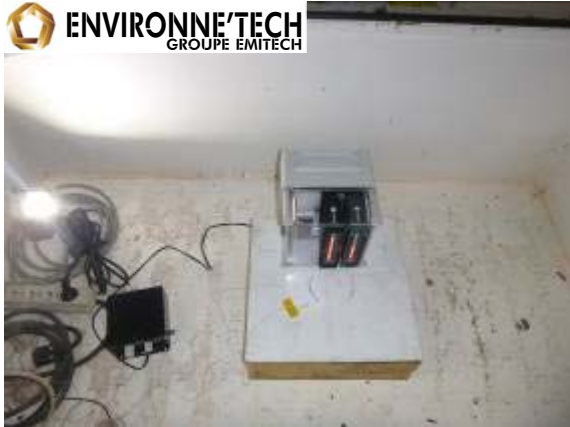
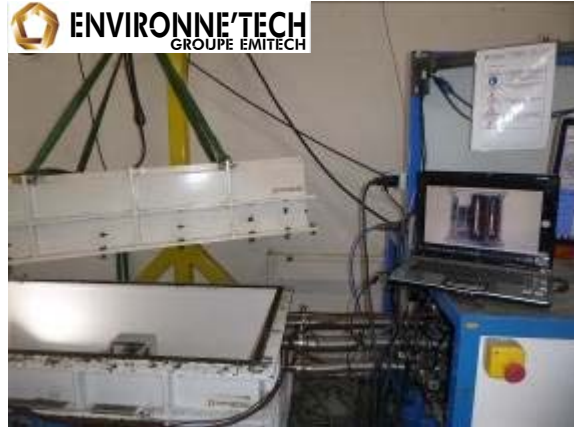
The equipment is placed in the climatic chamber and the thermocouples are installed, the test can begin.

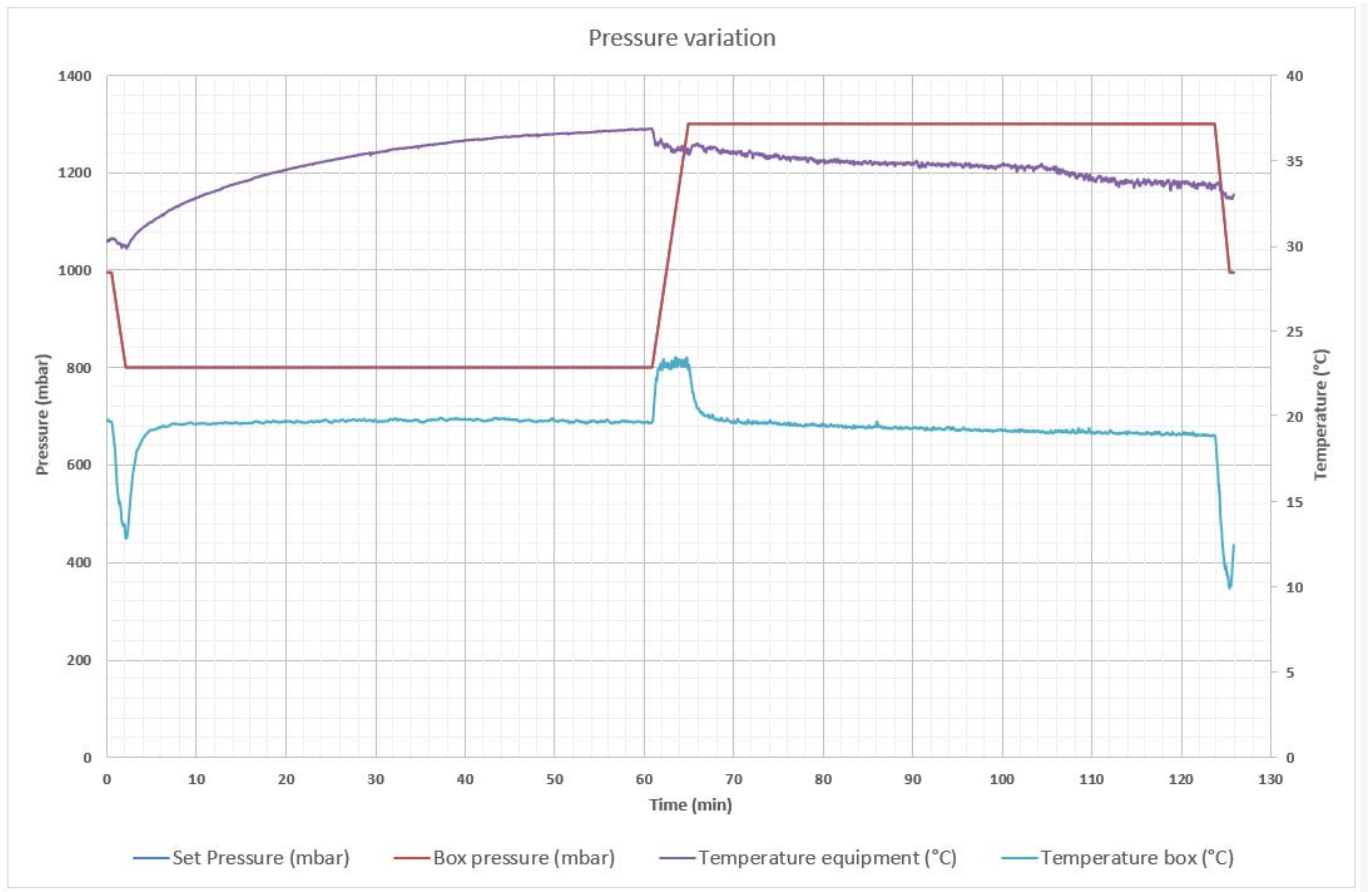
curve 1

- Type: Pressure variation
- Pressures: 700 and 1300mbar
- Pressure variations: <200mbar/min
- Duration of the stages: 1 hour
- Condition: ON equipment during testing

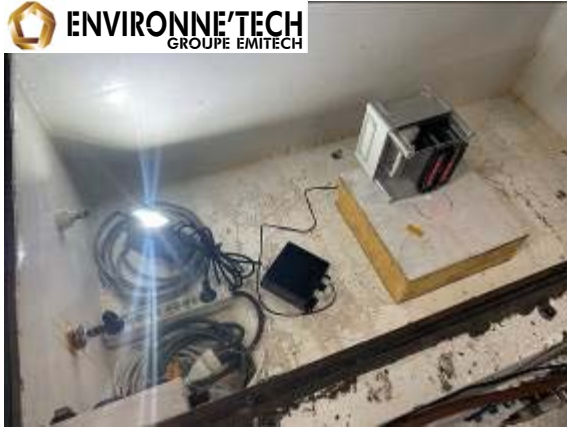
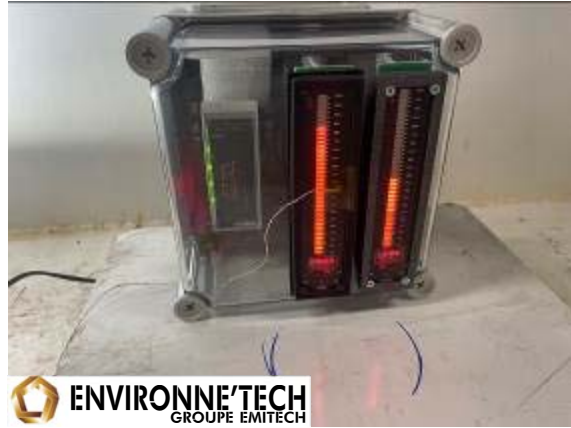
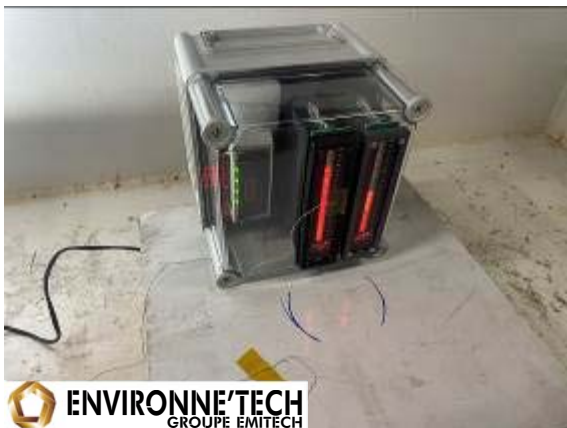
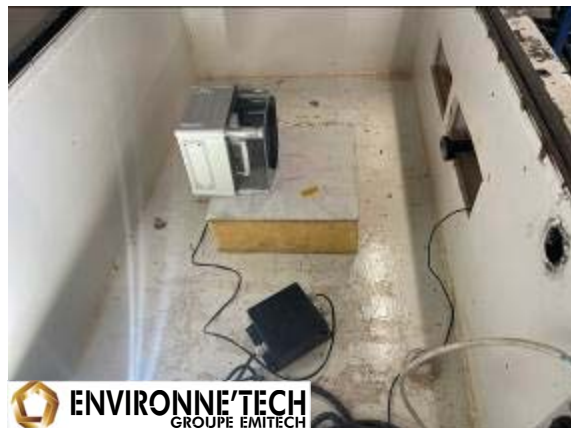
**Results:** At the end of the tests, no visual degradation was observed.

At the end of the tests, no visual degradation was observed.
